Edge Cracking in Hot Mix Asphalt Pavements

Final Report

Colorado Asphalt Pavement Association
Englewood, Colorado

Scott Shuler
Associate Professor
Department of Construction Management
Colorado State University
Ft. Collins, Colorado

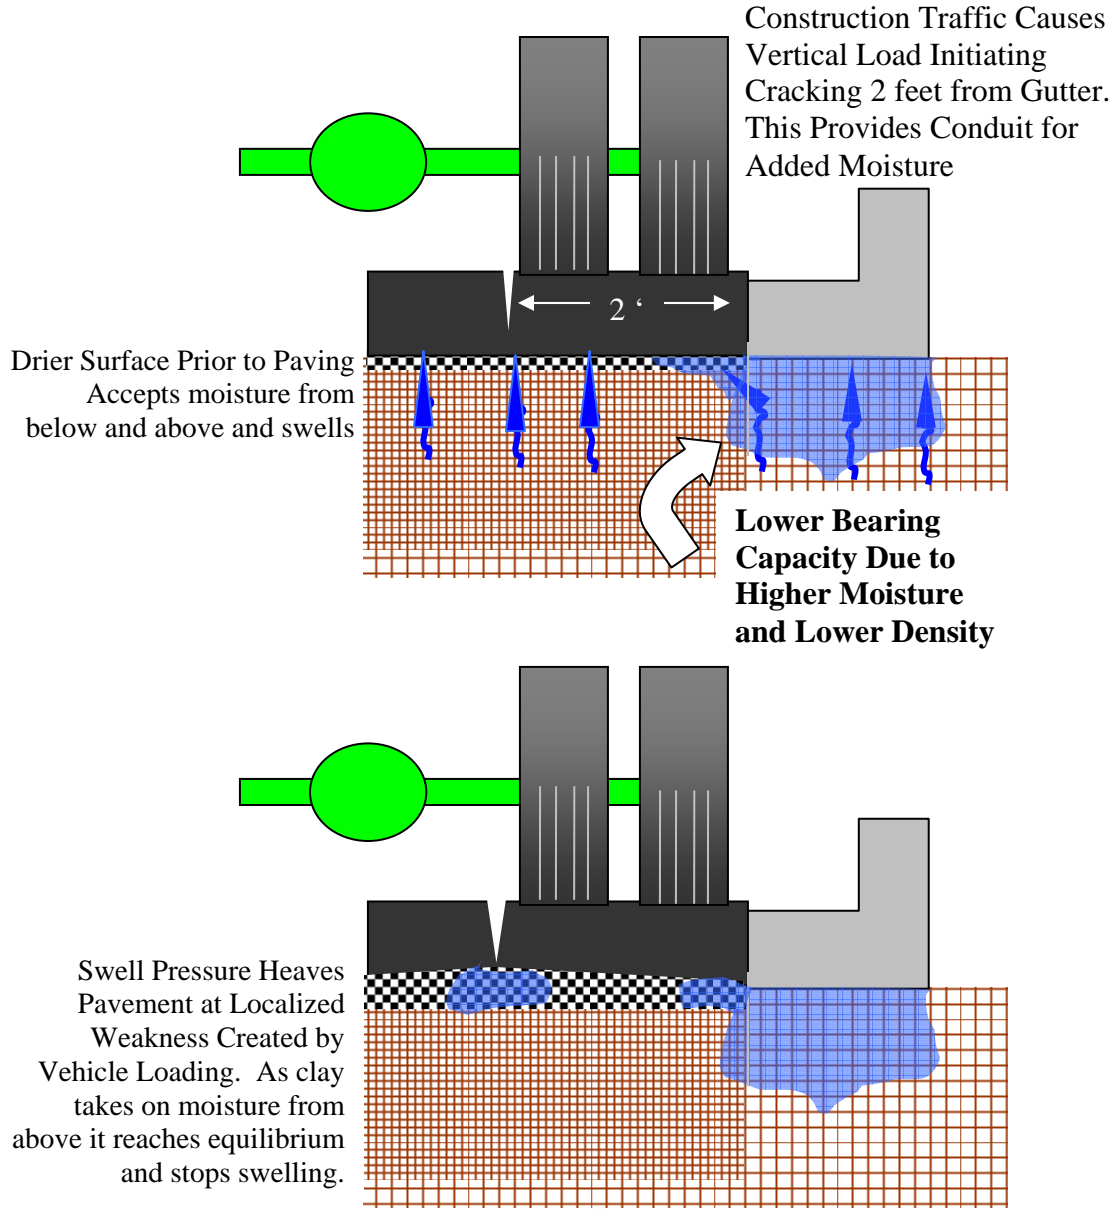
Figure 6 – One Possible Mechanism for Edge Cracking in Full-Depth Sections

In the full-depth section, the situation is represented in Figure 5. Cracking is probably not caused by the weight of the concrete curb and gutter and hot mix asphalt pavement, alone. However, if an external load provided by construction traffic were placed at or near the edge of the hot mix asphalt pavement, the lower bearing capacity may not support the load, and a tensile crack could be initiated at the surface as shown in Figure 6. The swelling pressure from below then heaves the pavement slightly at this location due to the localized weakness. As the crack propagates through the hot mix asphalt pavement moisture flows to the surface of the clay subgrade. Although this surface moisture probably cannot penetrate the clay significantly, it may be enough to cause some localized swelling. As the moisture content increases to equilibrium, swelling ceases and cracking stops.

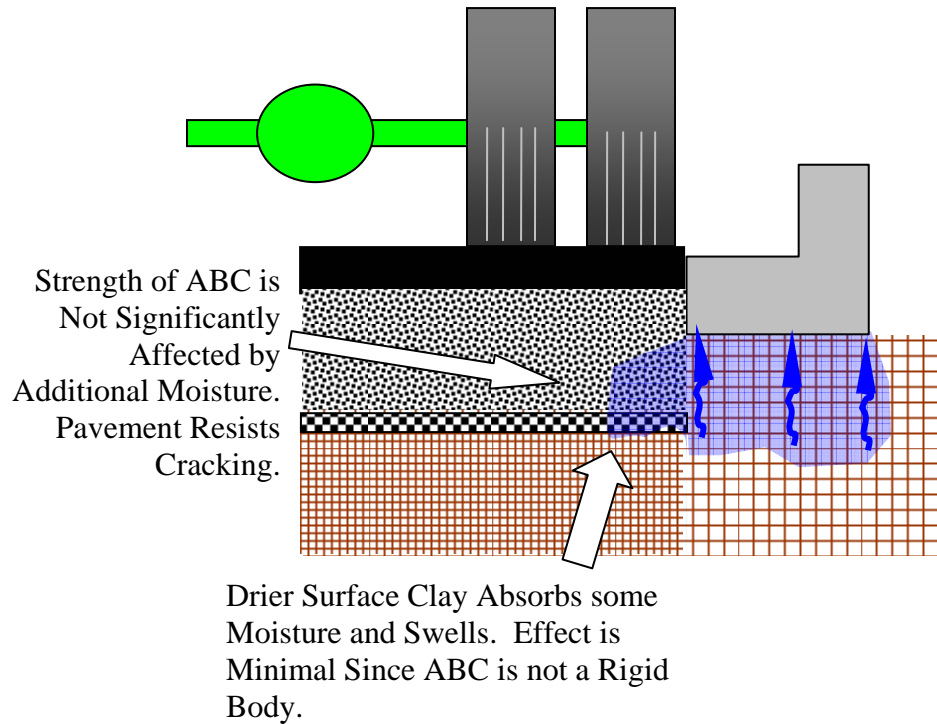
Figure 7 – Possible Explanation for Lack of Edge Cracking in Composite Sections

Figure 7 depicts how this mechanism would be hindered by the composite pavement section. The aggregate base course strength is not as susceptible to bearing capacity failure as the clay subgrade soils for an equal increase in moisture content. Therefore, construction traffic is less likely to create a surface crack in the hot mix asphalt pavement even though moisture content under the curb and gutter is higher than desired. Since the drier subgrade surface is beneath the aggregate base course (ABC) in this section, any swelling of the clay occurs beneath the ABC. And since the ABC is not a rigid body, it can absorb much of this strain without affecting the hot mix asphalt pavement 8 inches or more above.

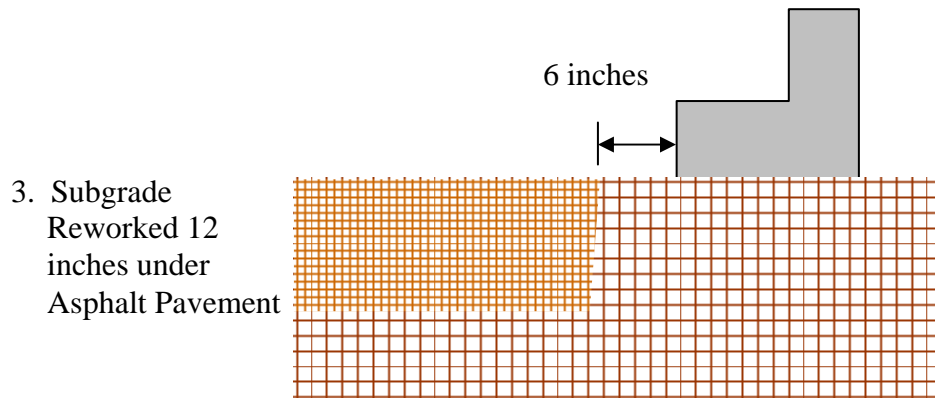
Figure 8 – Alternative Full-Depth Hot Mix Asphalt Pavement Subgrade Preparation

Another possibility is that during the subgrade preparation between the curb and gutter, the subgrade is not reworked immediately adjacent the concrete gutter. This may be for at least two reasons: 1) the equipment being used to prepare the subgrade is not physically capable of working immediately adjacent the gutter, or 2) the contractor preparing the subgrade is reluctant to work too close to the freshly placed concrete for fear of damaging the new gutter. In this case, the reworked subgrade might look more like that shown in Figure 8 where the subgrade prepared for paving is perhaps 6 inches away from the gutter. The mechanism for failure is the same as described previously, except the potential for moisture movement in the soil adjacent the gutter is higher due to the lower density prior to paving.

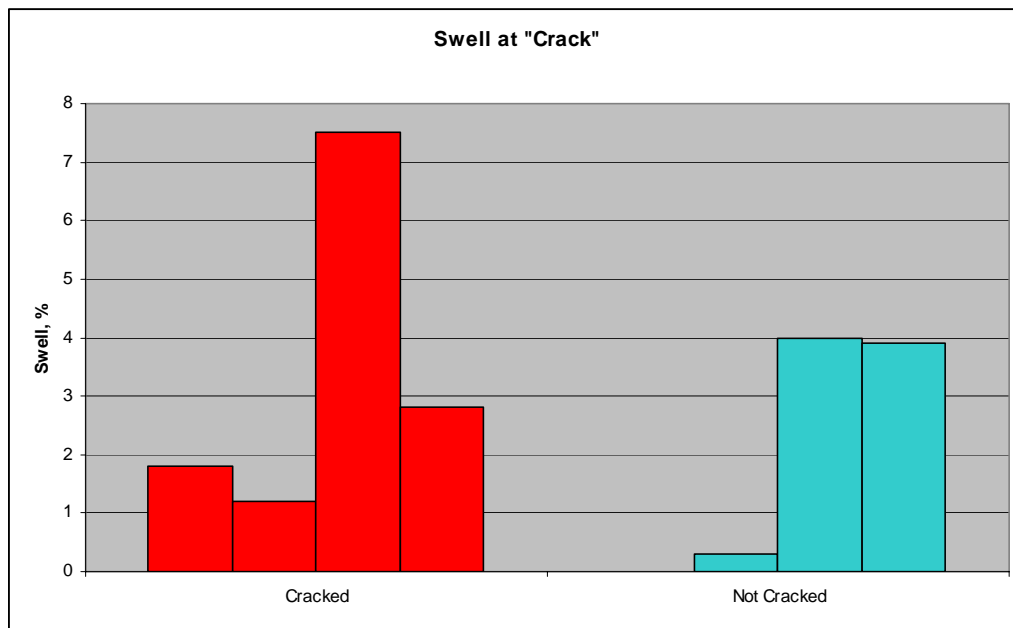
Figure 29 – Swell under Crack or Potential Crack Location

Figure 29 compares the swell potential for the cracked and uncracked pavements. Three of four cracked pavements had lower swell than the uncracked pavements. However, testing was conducted at insitu moisture contents, which may have been near or above optimum moisture. At these moisture contents significant swelling would not be expected. Therefore, since the swelling mechanism could create a crack originating at the surface of the pavement, swelling should remain a potential candidate for contributing to edge cracking.

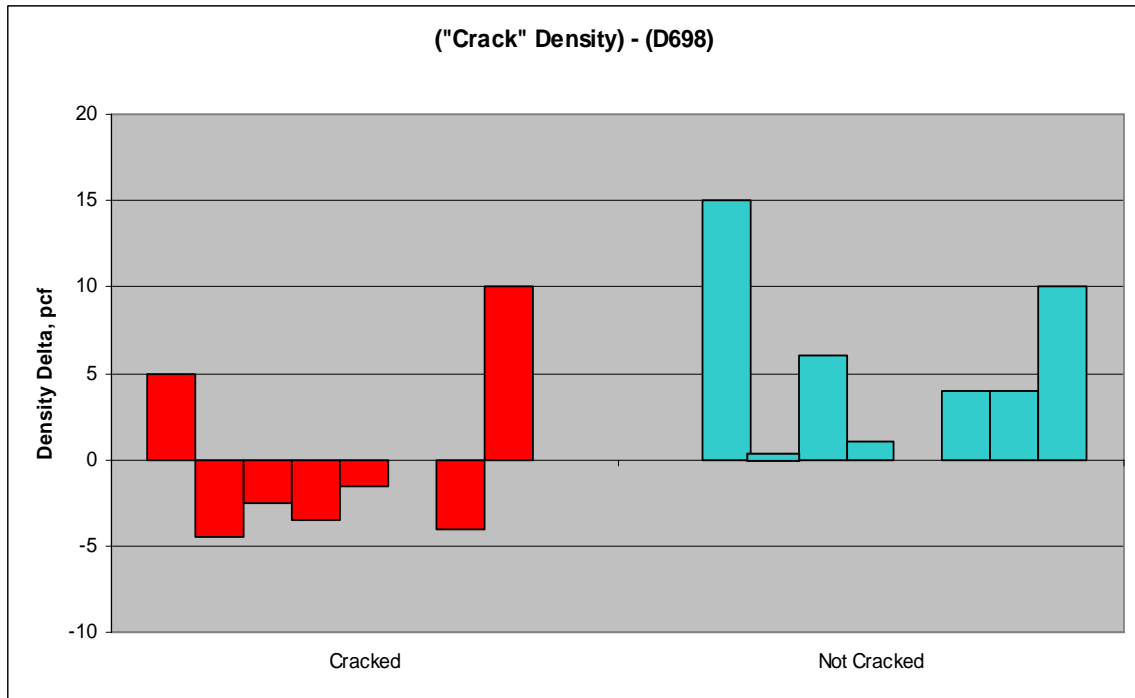
Figure 30 – Difference between Density Insitu and Maximum Density (ASTM D698)

Figure 30 compares the difference between subgrade insitu density and the maximum density determined by ASTM D698 for the cracked and uncracked pavements. There appears to be a trend to densities lower than optimum under the crack. Compaction of the subgrade under the pavement is directly related to the load carrying capacity of the pavement. This factor could have much to do with edge cracking.

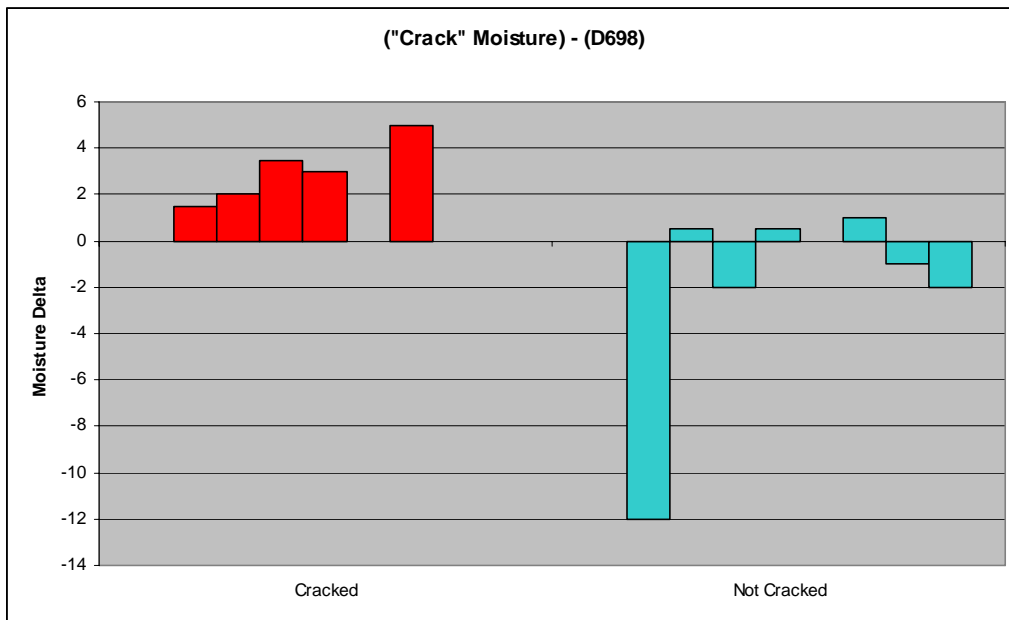
Figure 31 – Difference between Moisture Insitu and Maximum Density (ASTM D698)

Figure 31 compares the difference between subgrade insitu moisture content and the optimum moisture content determined by ASTM D698 for the cracked and uncracked pavements. Moisture content appears to be at least 1% lower than optimum under the uncracked pavements and approximately 2% or greater above optimum under the cracked pavements. The moisture content of the subgrade under the pavement is directly related to the load carrying capacity of the pavement. This factor could have much to do with edge cracking and could be the reason compaction was lower than desired.

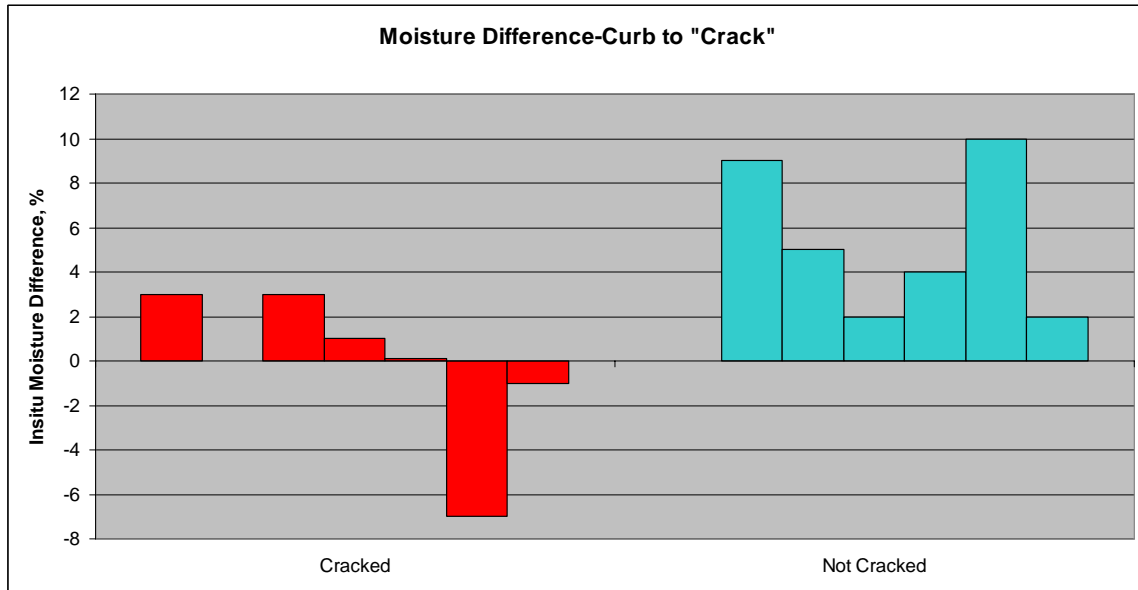
Figure 32 – Moisture Difference From Behind Curb to Crack or Potential Crack Location

These data indicate that edge cracking occurs more frequently when the moisture content of the subgrade behind the curb is equal to or lower than moisture under the crack or potential crack location.

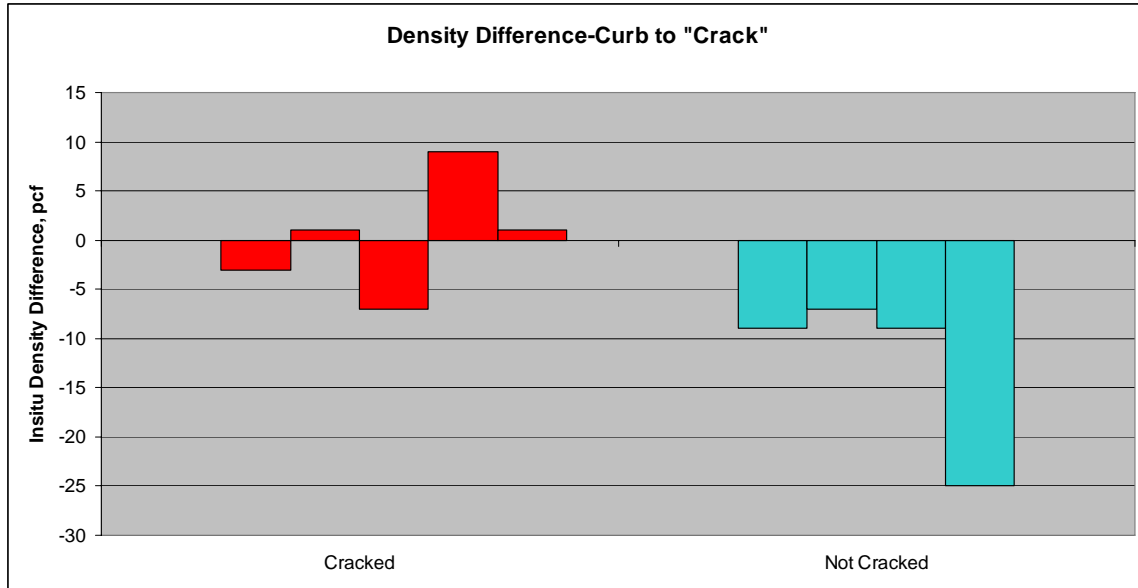
Figure 33 – Density Difference From Behind Curb to Crack or Potential Crack Location

In addition, it appears that edge cracking occurs more frequently when the density of the subgrade behind the curb is higher than density under the crack or potential crack location. Therefore, it appears a lack of support under the curb and gutter due to high moisture or low density is not the cause of edge cracking for the sites studied.
