Edge Cracking in Hot Mix Asphalt Pavements

Final Report

Colorado Asphalt Pavement Association
Englewood, Colorado

Scott Shuler
Associate Professor
Department of Construction Management
Colorado State University
Ft. Collins, Colorado

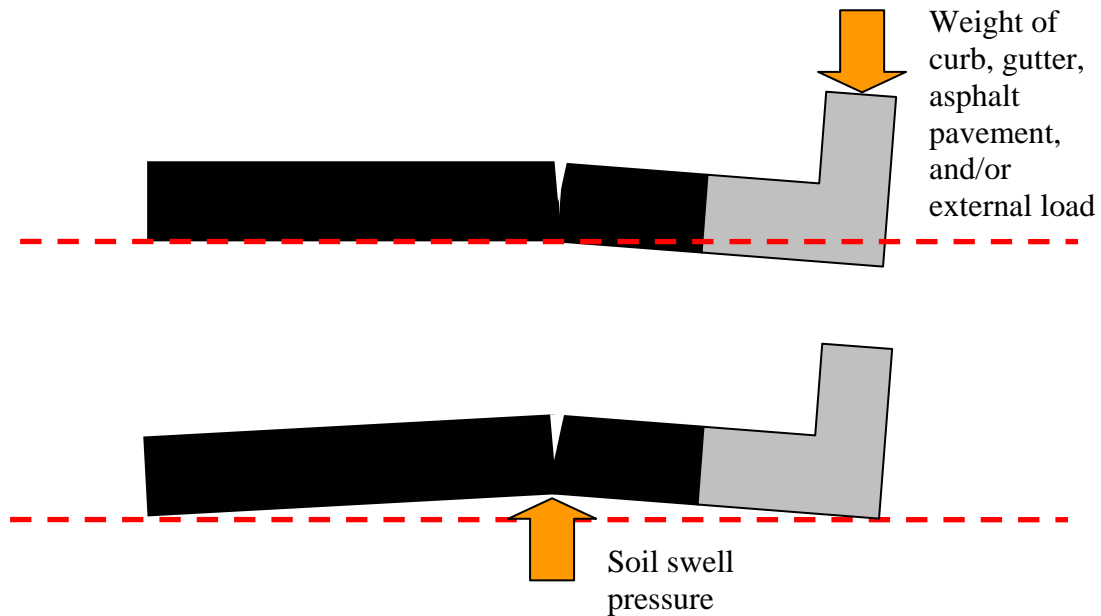
Figure 2 – Possible Forces Causing Edge Cracking

If cracking initiates at the top of the pavement then a bending moment must be developing in the area of the crack which creates a strain exceeding the failure strain of the hot mix asphalt pavement. This bending moment can occur by the mechanisms shown in Figure 2. One, the curb, gutter and hot mix asphalt pavement between the gutter and crack can move downward caused by a downward acting force such as gravity or external loads or, two, the pavement can move upward by a force acting in the vicinity of the crack such as soil swell pressure. Or, three, a combination of these forces.

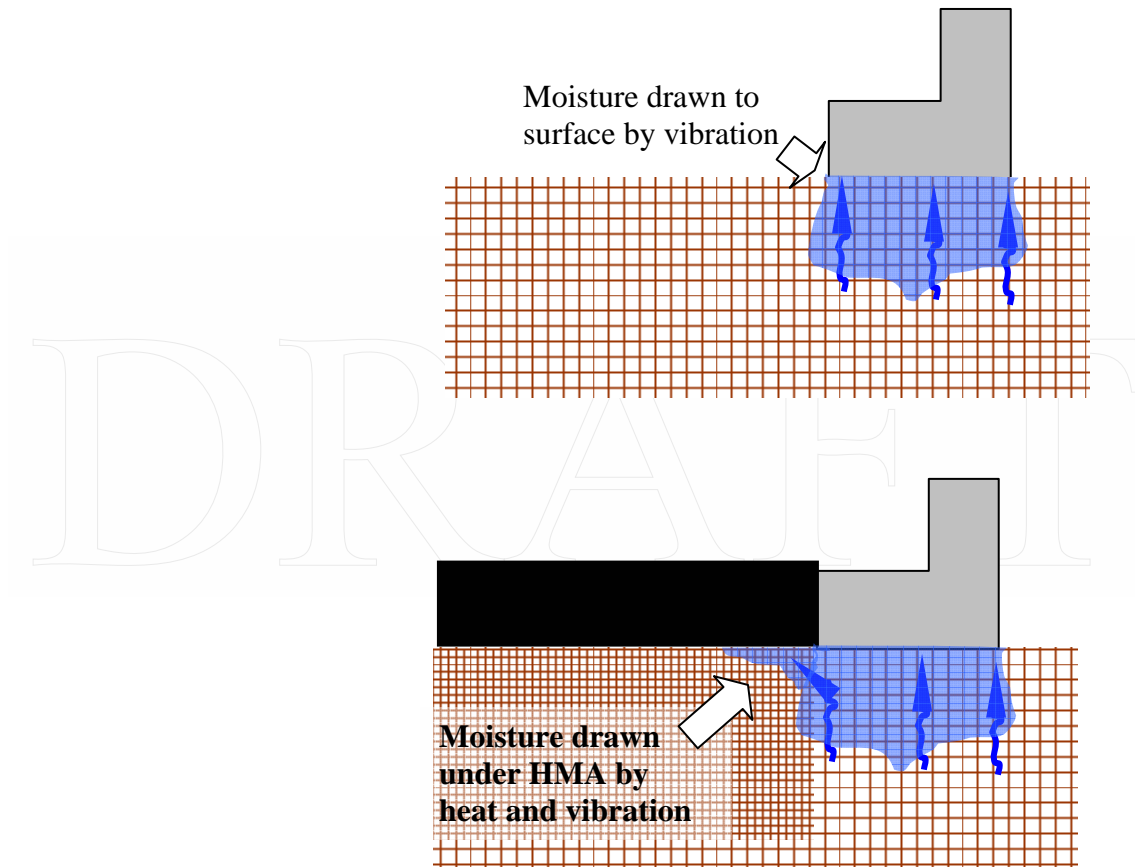
Figure 5 – Possible Moisture Movement to Surface after Slip-Form Vibration and Paving

It is possible that moisture in the clay subgrade is drawn toward the surface by mechanical means, such as the vibration generated by the slip-form paver when constructing the curb and gutter, or the vibration produced by the vibratory rollers and heat generated in the soil by the hot mix asphalt. It is also possible the moisture and density of the subgrade under the curb and gutter are not at or near the optimum values desired. They may be higher than optimum moisture and lower than optimum density. This might particularly be true for cut sections where insitu density would be expected to be lower than that produced by mechanical compaction. If the soil is not compacted to greater than 95% of D698 under the curb and gutter, movement of water through the soil would be facilitated. It is also possible moisture could move up in the soil, even with adequate compaction. This is something that should be evaluated in the field. Assuming that moisture is pulled to the surface of the soil under the curb and gutter, the moisture content would be higher near the surface than testing would have indicated if done prior to curb placement. Also, it is possible that the density of the soil is lower than desired. If so, this may be the first step to explaining the pavement cracks.

In the full-depth section, the situation is represented in Figure 5. Cracking is probably not caused by the weight of the concrete curb and gutter and hot mix asphalt pavement, alone. However, if an external load provided by construction traffic were placed at or near the edge of the hot mix asphalt pavement, the lower bearing capacity may not support the load, and a tensile crack could be initiated at the surface as shown in Figure 6. The swelling pressure from below then heaves the pavement slightly at this location due to the localized weakness. As the crack propagates through the hot mix asphalt pavement moisture flows to the surface of the clay subgrade. Although this surface moisture probably cannot penetrate the clay significantly, it may be enough to cause some localized swelling. As the moisture content increases to equilibrium, swelling ceases and cracking stops.

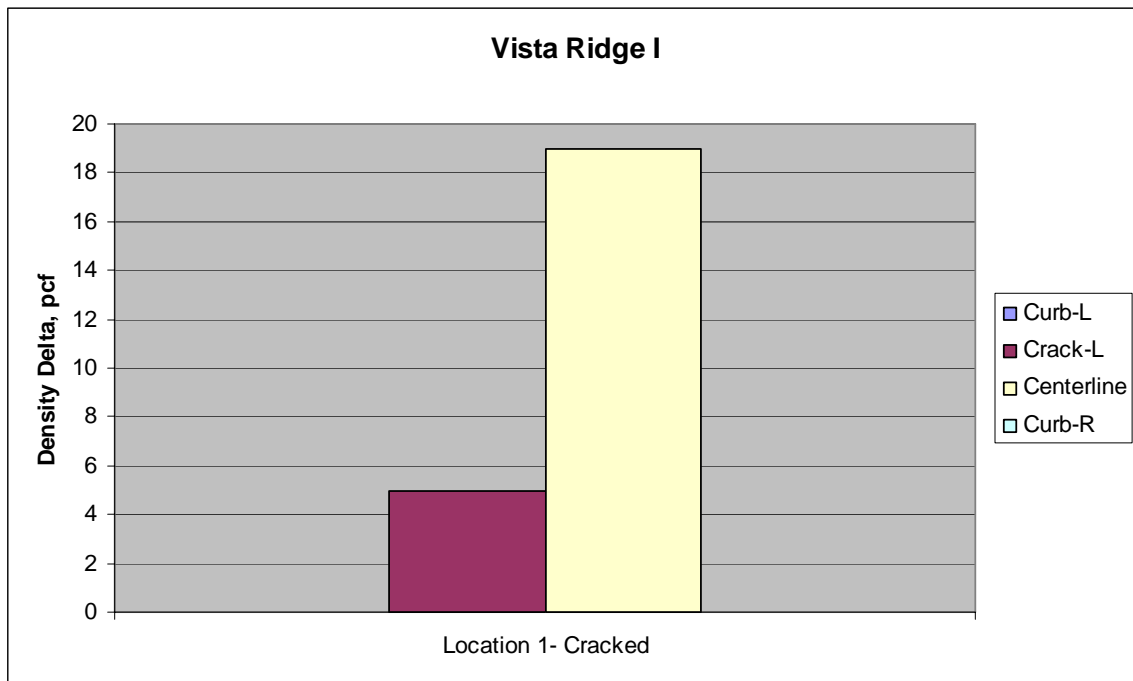
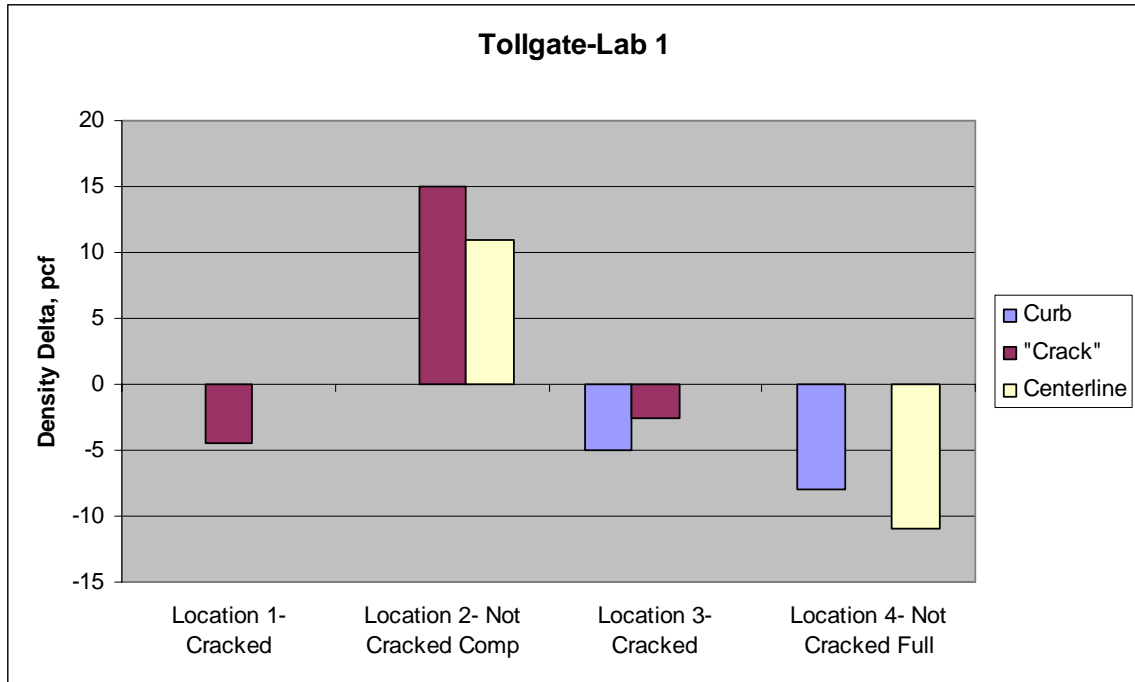
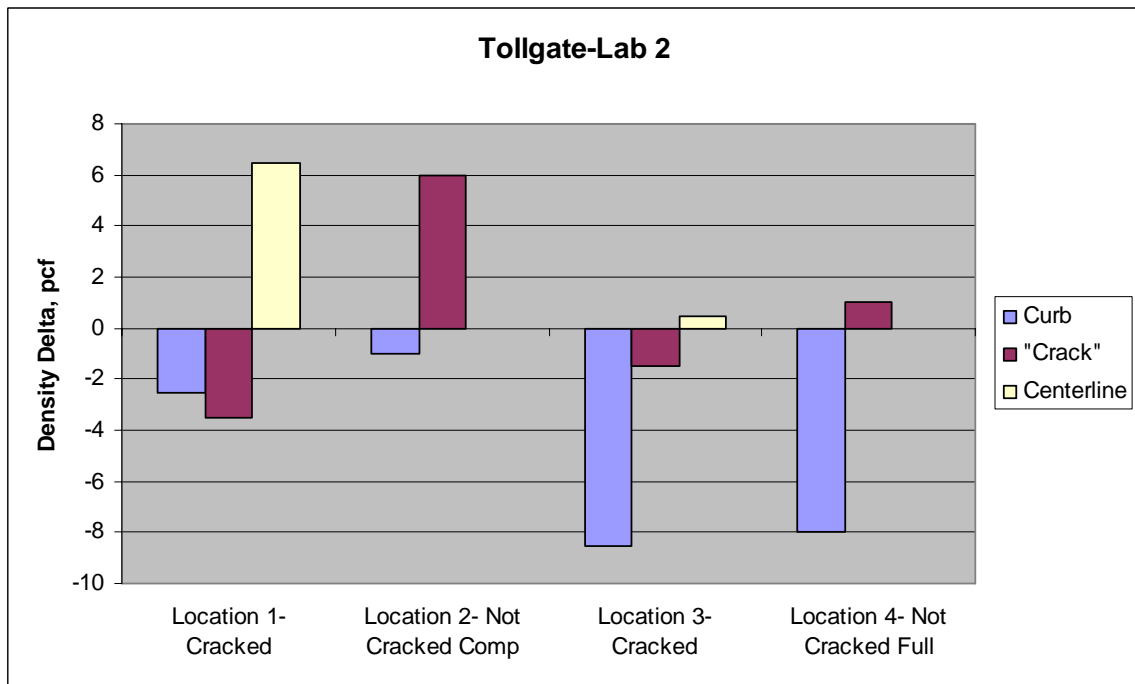
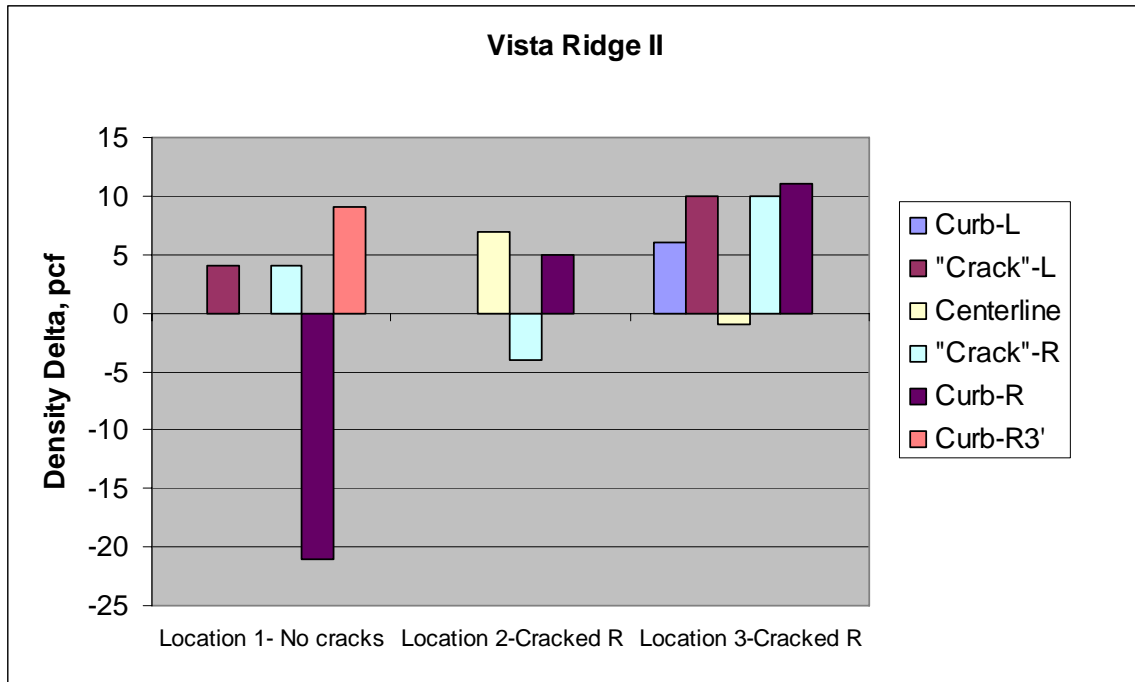
The moisture contents and density of the insitu soils beneath the pavements and behind the curbs were compared to the optimum moisture and density determined using ASTM D698, "Moisture Density Relationships for Soils." Results of these comparisons are shown in Figures 15 through 18 for the density results and Figures 19 through 22 for the moisture results.

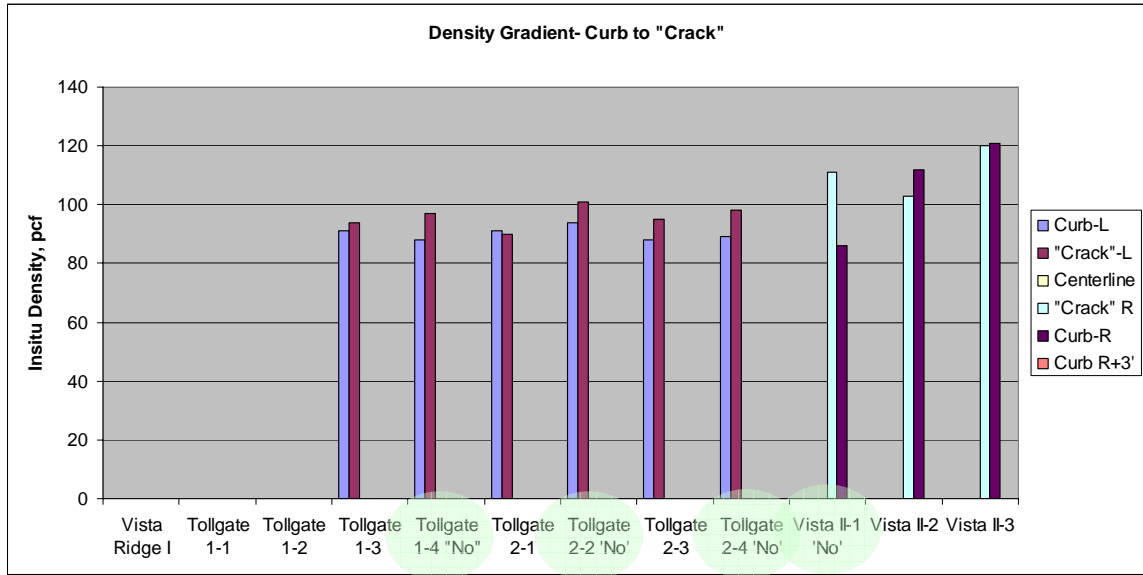
Figure 23 – Density Gradient Curb to “Crack”

Table 6 – Density Gradient Curb to “Crack”

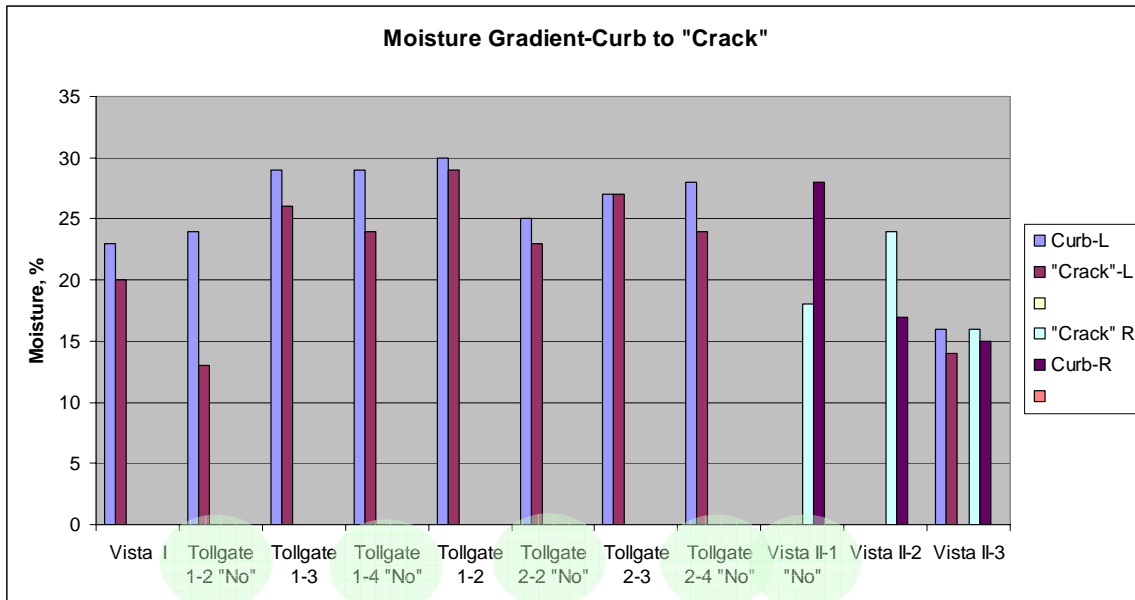
Figure 24 – Moisture Gradient Curb to “Crack”

Table 7 – Moisture Gradient Curb to “Crack”

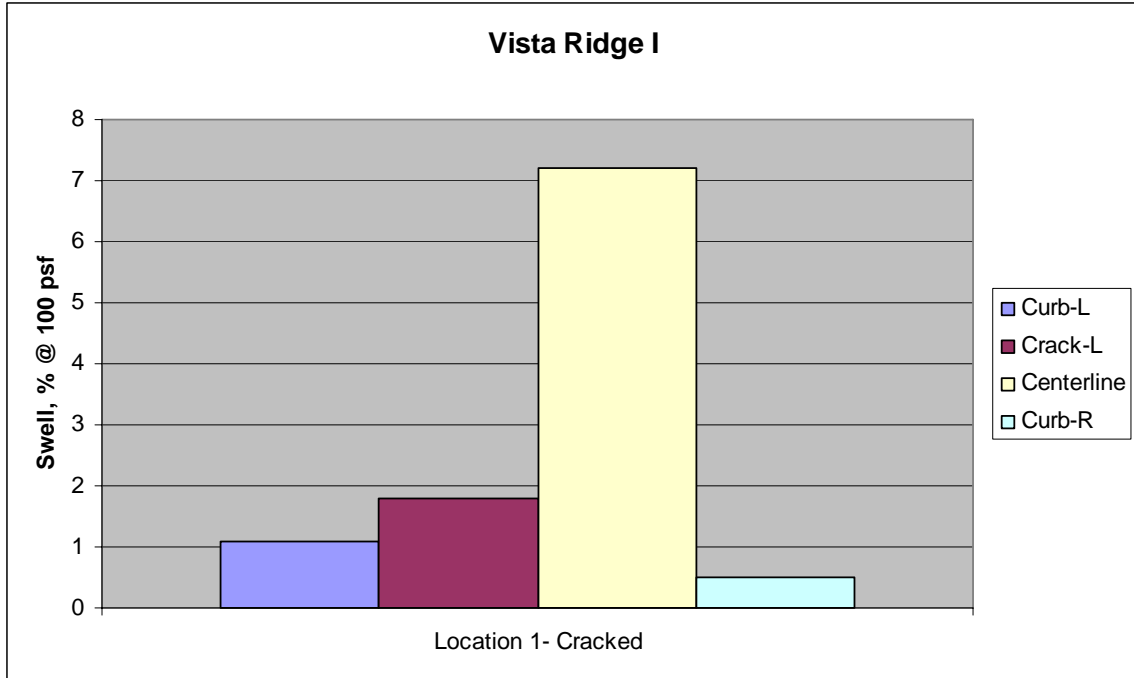
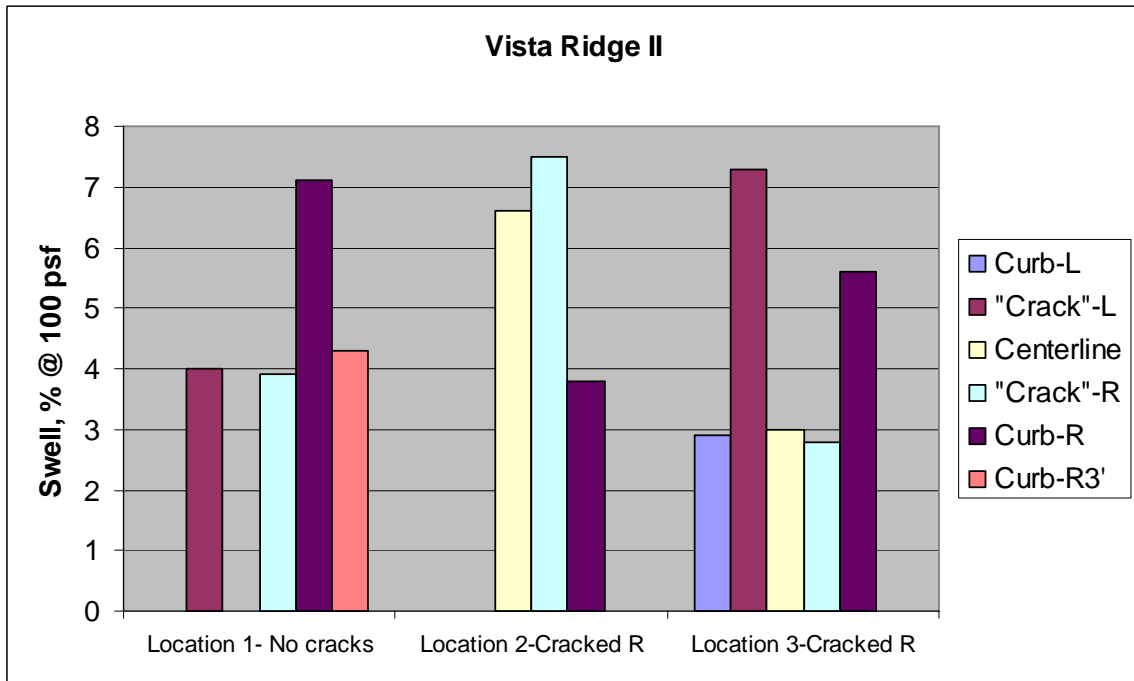
The swell potential of the subgrade soils was evaluated at 100 pounds per square foot surcharge. The actual surcharge varied with each site depending on the actual pavement thickness. The actual surcharge in the case of Tollgate Crossing with 5-1/2 inches of full-depth asphalt pavement is approximately 69 psf, and approximately 100 psf in the composite section. Vista Ridge has approximately 113 psf. However, the difference between these values should not be considered significant with respect to swell behavior and the consistent 100 psf surcharge used allows better comparison between sites.

The results of this evaluation are shown in Figures 25 and 26 for swell percentage and Figures 27 and 28 for swell pressure.
